**ROAD IMPROVEMENT MANUAL**

**TOWNSHIP OF ANTIS**

**2015**

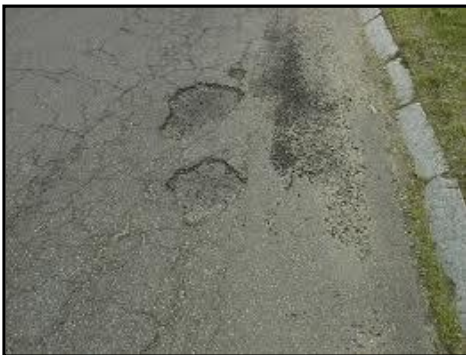
Description: Spalding of the pavement surface causing the asphalt wearing course to separate from the binder course. Raveling can occur in isolated area or across the entire surface, although the wheel tracks are typically the worst areas.

<b>Slight</b>	Less than 8" in width and less than 1.5" depth.
<b>Moderate</b>	From 8" to 15" in width and 1.5" to 2.5" in depth.
<b>Severe</b>	More than 15" in width and greater than 2.5" in depth.

**Slight**

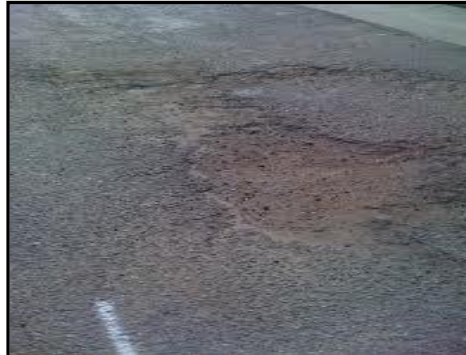
**Moderate**

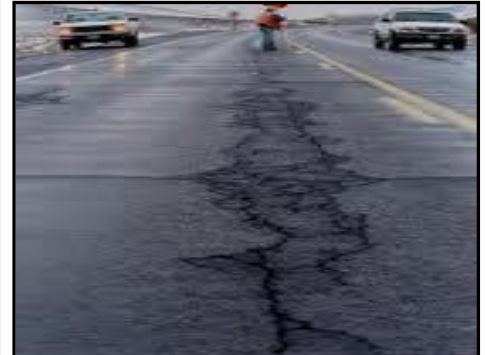
**Severe**

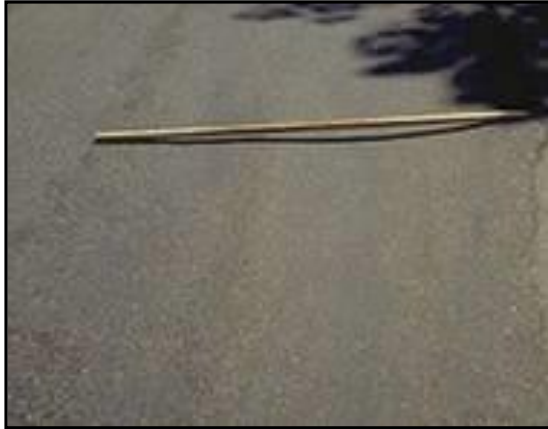
Description: Longitudinal depressions parallel to the direction of travel, typical forming in the wheel tracks.

<b>Slight</b>	Depth of the rut less than 0.5".
<b>Moderate</b>	Depth of the rut from 0.5" to 1".
<b>Severe</b>	Depth of the rut is greater than 1"

**Slight to Moderate**

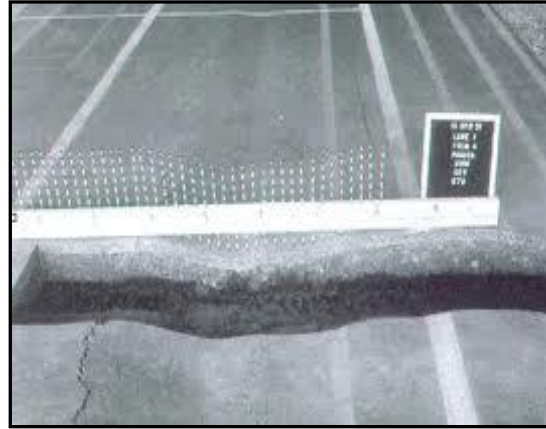
**Moderate to Severe**

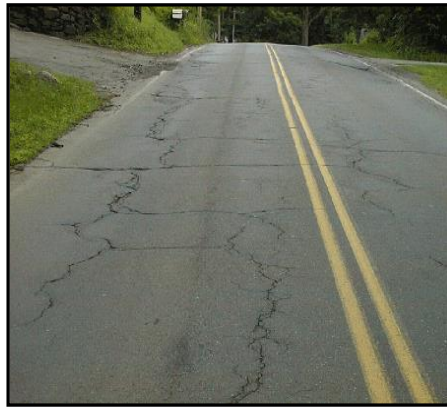
Description: Blocks of interconnecting cracks resembling the skin of an alligator. The cracks are typically full depth, through the entire asphalt layer. Alligator cracks are an indicator of roadway base failure, which may require full depth reconstruction.

<b>Slight</b>	Fine, longitudinal hairline cracks running parallel to each other with no or only a few interconnecting cracks; the cracks are not spalled.
<b>Moderate</b>	Further development of light cracks into a pattern or network of cracks that may be lightly spalled; distortions of 1/4' to 1/2".
<b>Severe</b>	Cracks are spalled and pieces are well defined. Some blocks may be loose or missing. Distortions of 1/2" or more.

**Moderate**

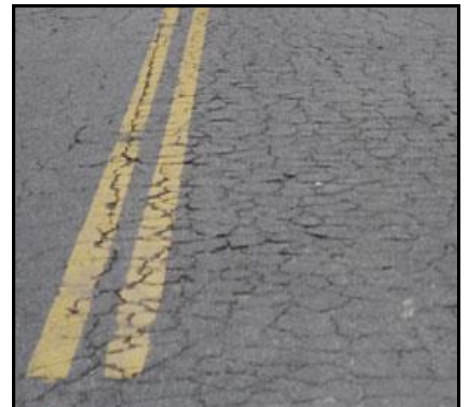
**Severe**

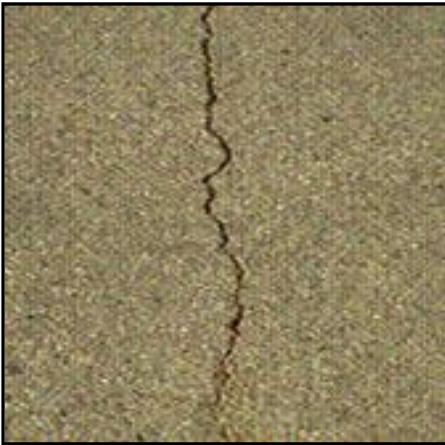
Description: Cracks which usually appear across the road perpendicular to the centerline. They typically affect the wearing asphalt course and are usually not traffic load-related.

<b>Slight</b>	Hairline cracks less than 1/8" in width.
<b>Moderate</b>	Cracks 1/8" to 1/2" in width.
<b>Severe</b>	Cracks greater than 1/2" in width.

**Slight**

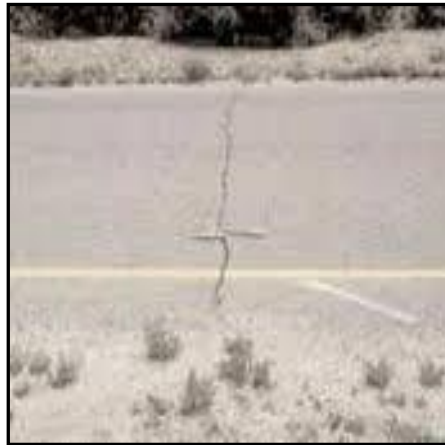
**Moderate**

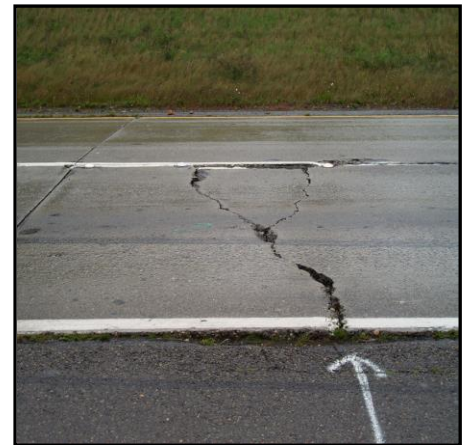
**Severe**

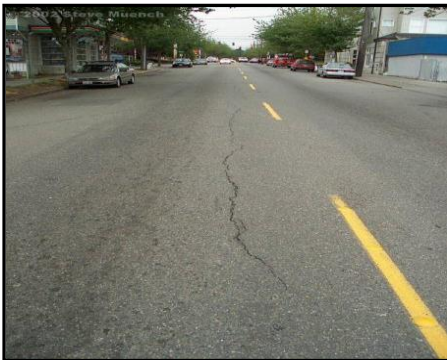
Description: Cracks which follow along the road parallel to the centerline.

<b>Slight</b>	Hairline cracks less than 1/8" in width.
<b>Moderate</b>	Cracks 1/8" to 1/2" in width.
<b>Severe</b>	Cracks greater than 1/2" in width.

**Slight**

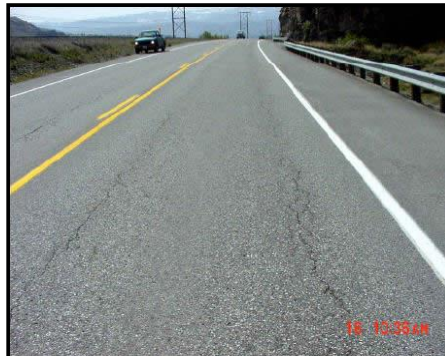
**Moderate**

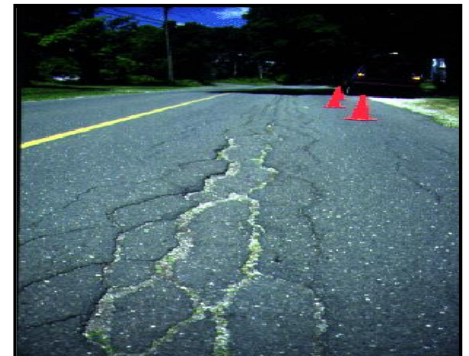
**Severe**

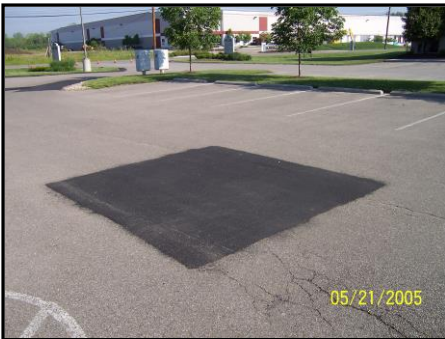
Description: A surface patch is where the top layer of roadway material has been replaced. Poor patching may be uneven, heavily rutted, contain different cracks based on quality of patch, etc.

<b>Slight</b>	Good patch, no ruts or cracks.
<b>Moderate</b>	Moderate cracking.
<b>Severe</b>	Significant cracking or other distresses within the patched area.

**Slight**

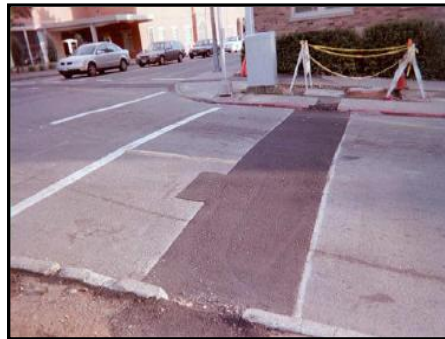
**Moderate**

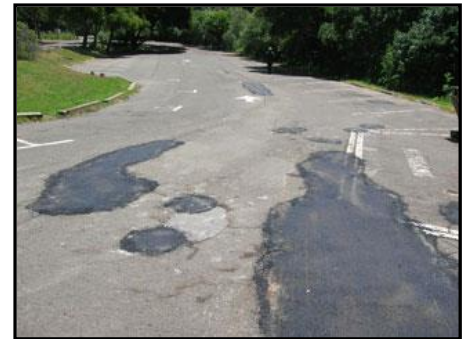
**Severe**

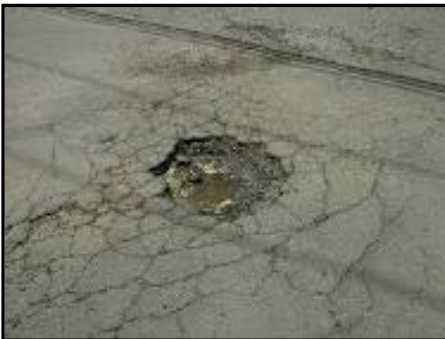
**Description:** Holes in the asphalt surface which may be isolated or caused by a combination of other progressively failing pavement defects. (raveling, alligator cracking, patching).

<b>Slight</b>	Less than 8" in width and less than 2.5" depth.
<b>Moderate</b>	From 8" to 15" in width and 2.5" to 4" in depth.
<b>Severe</b>	More than 15" in width and greater than 4" in depth.

**Slight**

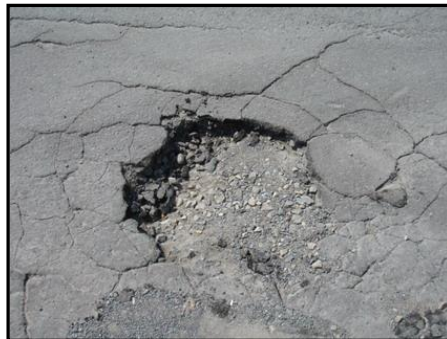
**Moderate**

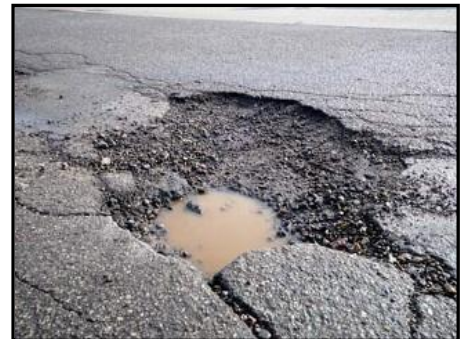
**Severe**
