SUSQUEHANNA RIVER BASIN COMMISSION

Juniata River Subbasin Year-1 Survey

Publication 274

A Water Quality and Biological Assessment June and July 2010

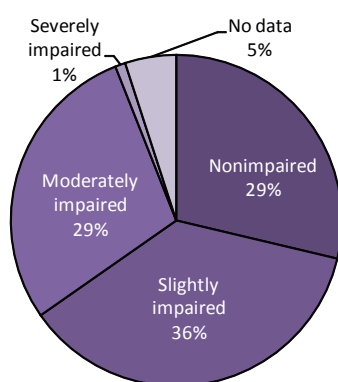
Figure 4. 2010 Biological Condition Categories for 101 Juniata Subbasin Sites

Ninety-six of those sites included a benthic macroinvertebrate collection. Twenty-nine sites (29 percent) had nonimpaired macroinvertebrate communities, 37 sites (36 percent) had slightly impaired communities, 29 sites (29 percent) had moderately impaired communities, and only one site had a severely impaired community (Figure 4).

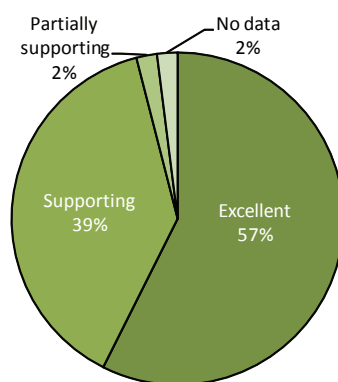
Figure 5. 2010 Habitat Condition Categories for 101 Juniata Subbasin Sites

A total of 99 sites were evaluated for habitat conditions, which on the whole were rated highly. Fifty-eight sites (57 percent) had excellent habitat, 39 sites (39 percent) had supporting habitat, and two sites (2 percent) had partially supporting habitat (Figure 5).
