# Blair County Collaborative TMDL and Pollution Reduction Plan

Blair County Intergovernmental  
Stormwater Committee

Prepared by:  
CENTER FOR WATERSHED PROTECTION

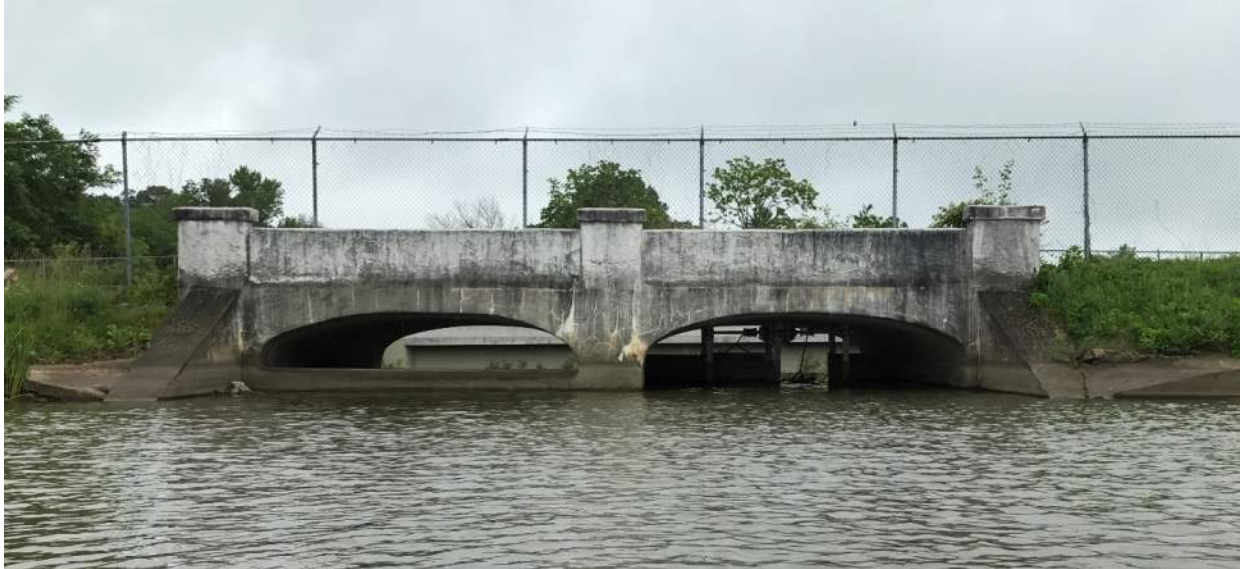
Figure 8 - Photograph from June 7, 2017 Detailing that the Water Surface Elevation is Approximately 8 Inches Below the Spillway Crest Opening

During the June 7, 2017 field survey, it was also observed that the spillway was not at the 1006 ft elevation described in the dam inspection report (Figure 8). If the spillway crest opening is indeed 2 ft,

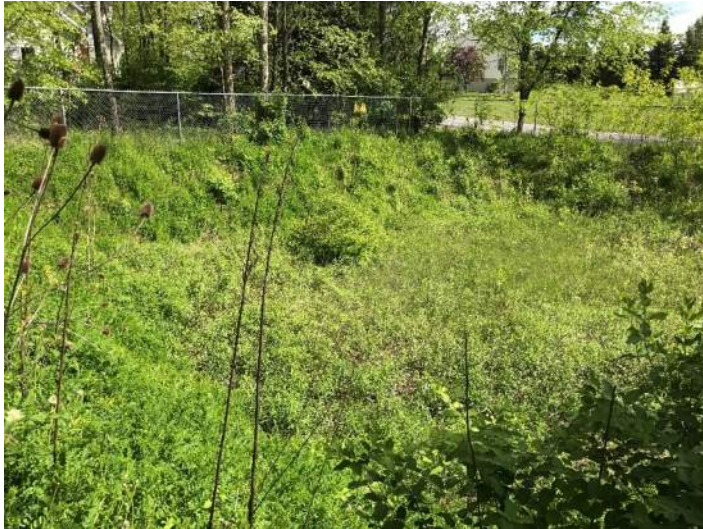
## Adams Basin 1 (TMDL\_P\_BR\_1)

This basin provides rate control, but apparently provides negligible water quality treatment of storm flows. The hydrologic soil group in this location is B according to the Web Soil Survey, allowing for infiltration. Since little depth is available above the basin floor, it is recommended to excavate six or more inches to create retention volume, and to reduce the low-elevation orifice size to provide some velocity control in larger storm events. No access issues are present, and no utilities appear to present conflicts.

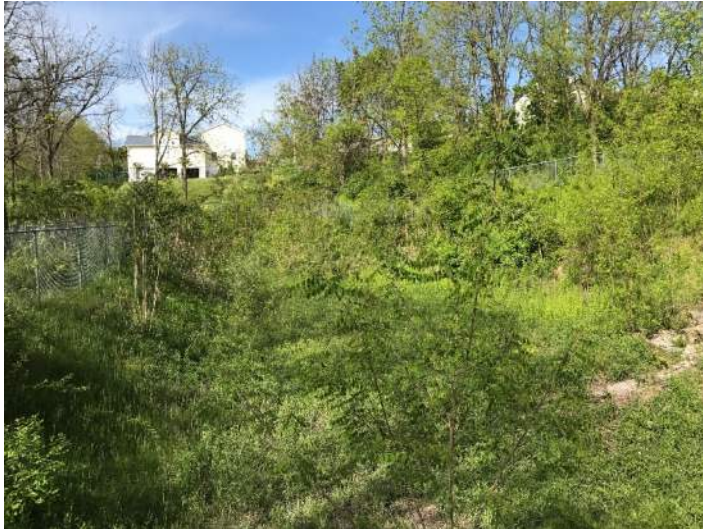
## Adams Basin 2 (TMDL\_P\_BR\_2)

There is significant head available between the existing basin floor and the outfall elevation. The outfall is stable. The hydrologic soil group is B according to the Web Soil Survey. Excavation to add retention and infiltration capacity is possible to achieve 0.08 ac-ft treatment. The only access or other constraint appears to be the slope to the basin through the adjacent homeowner's yard, though the property boundaries are unknown; the homeowner may simply be mowing some of the community stormwater management parcel for aesthetic maintenance.

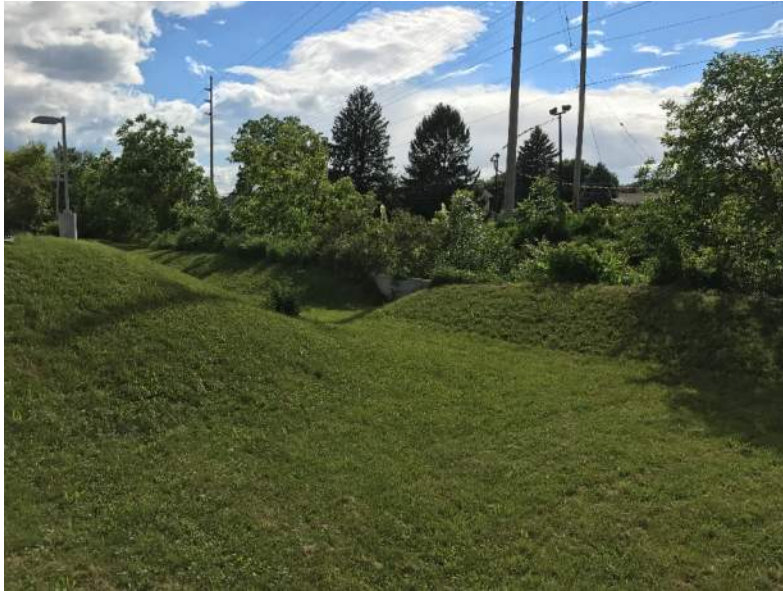
## Altoona Beauty School (PRP\_P\_BR\_2)

This is a very small basin, though the drainage area to it appears to also be quite small. No evidence of volume or detention time issues exists. The low-elevation orifice is four inches in diameter, and appears to do nothing to control flows. The outlet structure is immediately adjacent to an upstream portion of Brush Run. It is recommended to block the low-elevation orifice. No freeboard or flooding issues should arise from this action, as the secondary orifice is at eight inches above the basin floor elevation, and the overflow weir is 14 inches above that. No access issues exist, and no utility conflicts are apparent.

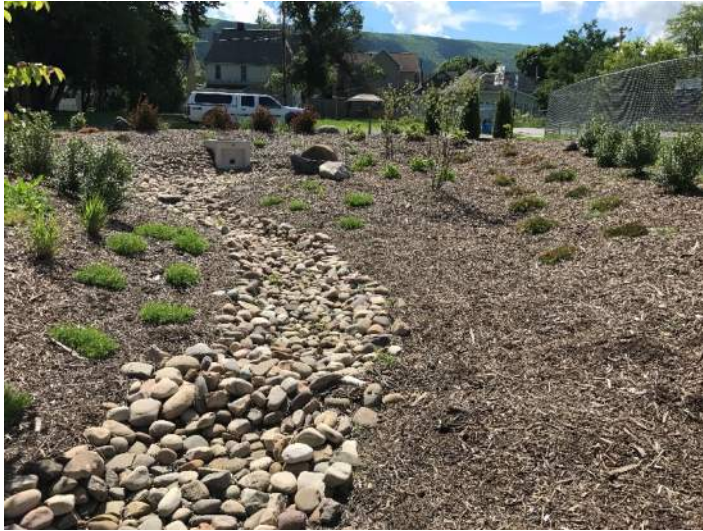
## Bellwood – Antis Park (PRP\_E\_RG\_5)

A rain garden was recently installed inline with a drainage conveyance swale that leads to Bells Gap Run on the south side of Bellwood-Antis Park. The rain garden includes educational signage, and is well constructed.

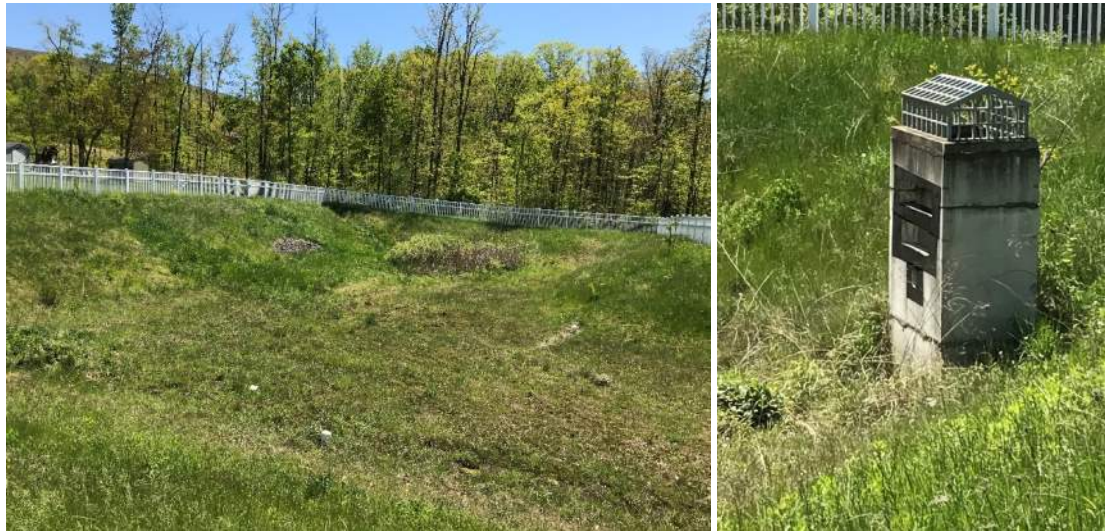
## Brush Oaks Development Pond 2 (TMDL\_P\_BR\_5)

The Brush Oaks 2 basin captures runoff from several homes and a portion of Brush Oaks Drive. The outlet structure appears to be designed for extended detention with several staged outlets, though based on visual inspection and conversation with the adjacent homeowner, detention time is very short (less than a couple hours in very heavy storms) with the water level only ever reaching approximately one-foot depth. A small amount of treatment is currently provided by some incidental wetland vegetation, but retention could be expanded significantly by blocking or raising the low-elevation orifice, which would foster more wetland vegetation and provide more water quality treatment. There are no apparent utility or access constraints. The adjacent homeowner, and/or the homeowners' association, may present some administrative constraints.

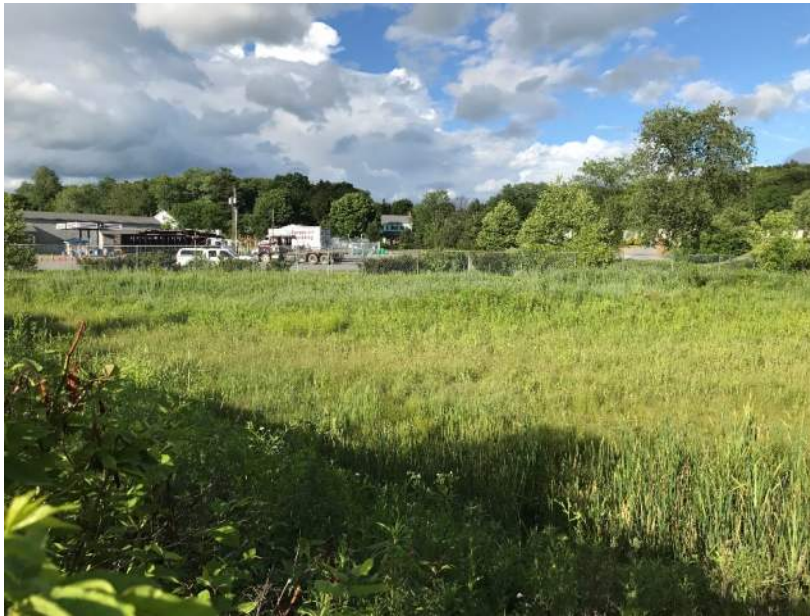
## Burgmeier's Hauling (TMDL\_P\_BR\_6)

The basin appears to be a simple detention pond for rate control, but due to soils and grades, wetland plants have been established, including fairly robust wooded wetland pockets in the channel leading to the basin, the roadside channel beside the basin, and across the street at the nearby intersection. The basin floor itself also retains a small amount of water and a small amount of wetland vegetation has taken hold. The floor of the basin has a significant slope upward to the east, reducing the potentially available volume. The floor could be excavated to increase retention. The low-flow, low-elevation orifice is sufficiently small to provide some rate control, though it could be raised or fitted with a perforated standpipe to provide longer detention, even above the increased retention volume from basin floor modification. No access or utility constraints are apparent.

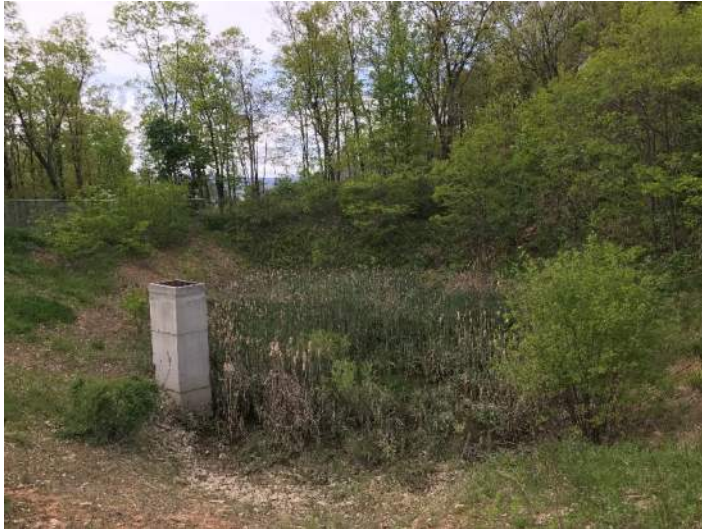
## Chapel Hill Pond 1 (PRP\_P\_BR\_9)

This basin currently has either no low-elevation orifice, or most likely a completely blocked and buried low orifice. Conversations with homeowners familiar with this basin indicate that the water level never rises more than another foot or so and only for very short times, and no visual indicators on the basin side slopes suggest otherwise. Due to probable blockage of the low-elevation orifice, there is approximately six inches of standing water in the basin which has fostered wetland vegetation throughout the basin floor. There is available head and space on the outlet structure to raise the low-elevation orifice to create greater retention without threatening any impacts on surrounding properties or roads. Recommendation is to raise orifice 18 inches, and add perforated standpipe for additional extended detention beyond that retention volume. Access is very easy, and no apparent access or utility conflicts exist.

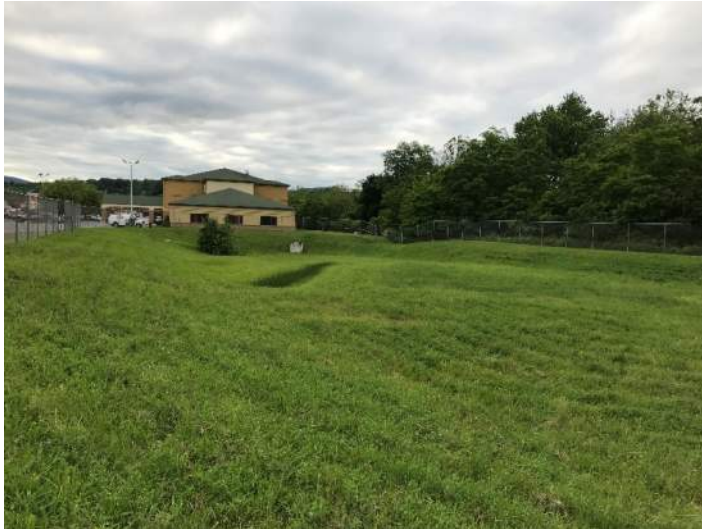
## Comfort Inn (PRP\_P\_BR\_10)

Recommendations: excavate the elevated portion of the basin floor, raise the low-elevation orifice, reduce the size of the replacement low-flow orifice, and either block or otherwise address the odd plastic pipes which seem to point generally northeast. This will create some retention volume, allowing the basin to provide some water quality treatment. Even without excavating, merely raising the low-elevation orifice, blocking it and drilling a new one, or installing a standpipe to raise the effective orifice invert elevation, will add retention volume, provided the pipes in the basin floor are not also acting as drains.

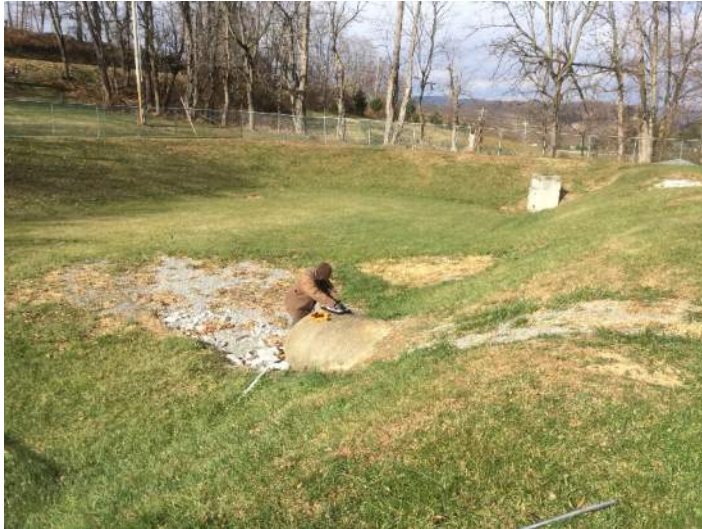
## Edgewood Dr. (Alpaca) Pond (PRP\_P\_WP\_12)

A dry pond currently functions to provide peak rate control for a range of storms, but does not provide any measurable treatment. A retrofit within the existing pond can provide some water quality treatment. The two options the Center recommends, in increasing order of benefit, are conversion from dry pond to dry extended detention water quality basin or conversion to permanent wet pond. The existing dry pond is well suited dimensionally to upgrade to either of these retrofit options. Dimensions of the bottom of the pond are approximately 51'x94', with height of 6'-7', and side slopes of approximately 3:1. The upgrade to an extended detention facility would require only changes to the existing outflow structure, restricting the lowest orifice.

Converting to a permanent wet pond, or semi-permanent wet pond, would require excavating the bottom of the pond 2'-6', verification that soils have low conductivity, installation of a simple sedimentation forebay, and possibly constriction of the lowest orifice of the outflow structure for additional downstream channel protection. Also, without knowing the subsurface conditions of the current outflow structure, it is possible that it would require either foundation modification, or replacement.

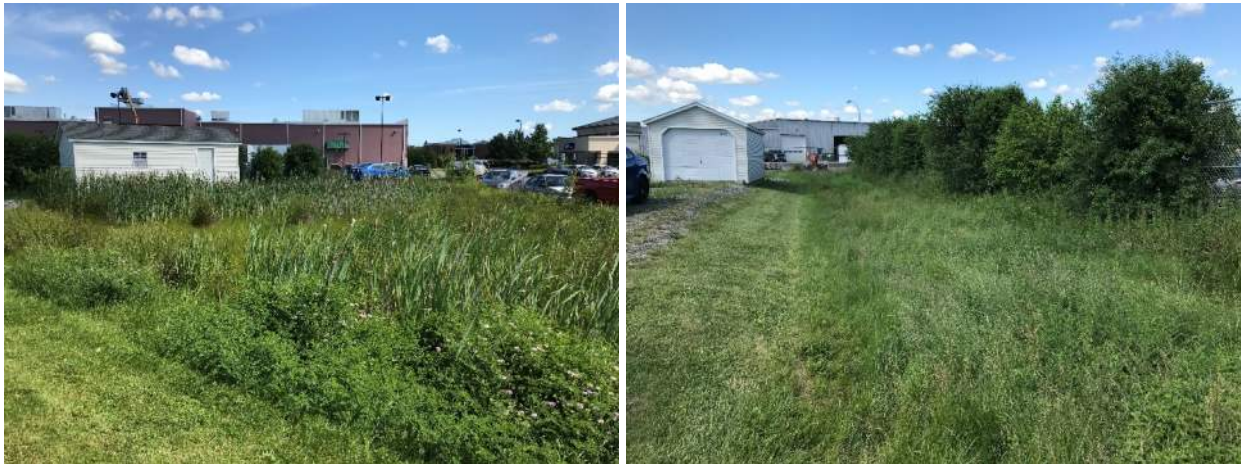
## Five Star Mitsubishi (PRP\_P\_WL\_13)

The basin at Five Star Mitsubishi is an oddity, in that no familiar design pattern is identifiable. It appears to be a rain garden style depression, with an overflow weir into a conveyance channel in the form of a vegetated swale. The larger portion of the runoff appears to bypass the rain garden area, which has now established some wetland vegetation throughout. Design plans or more thorough survey may be required. The only recommendation would be to excavate to add a little depth to the basin portion of this, or if there is available depth, excavate and add some sandy soil media to make the swale into more of a bioswale instead of merely a conveyance swale. Access is easy, but existing land use and site constraints preclude many options. Utility constraints are not easily identified.

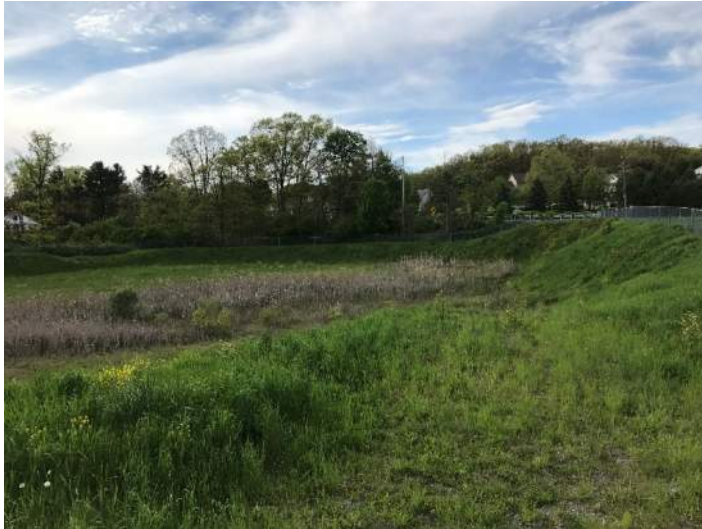
## Frankstown Township Detention Pond (PRP\_P\_WL\_15)

This detention pond has some wetland vegetation taking hold in a mostly direct path between the largest inlet and the outlet, and just in front of the smaller inlet. Though the Soil Survey suggests the hydrologic soil group is B, it is likely that they are C or less permeable. The basin floor is large and open, and access is easy with both an access point off the road, and a shallow ramp into the basin. The low-elevation outlet is a caged rectangular orifice. Partially blocking this could be the low-investment option for adding retention volume to the basin. Another option would be to excavate some pools, or perhaps even the entire floor, which would likely create more of a wetland retrofit, adding to the existing wetland vegetation currently in place. Both actions together would add retention and some peak volume shaving to help protect downstream channels. As mentioned, access is easy and open. There are no apparent utility conflicts.

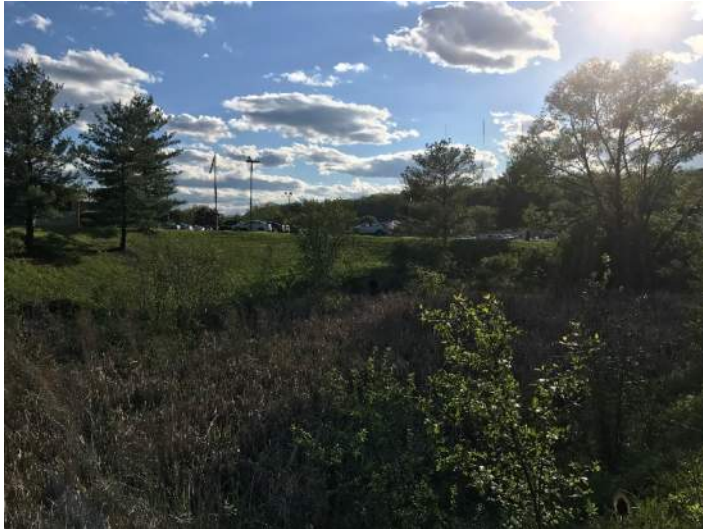
## Healtsouth 1 (PRP\_P\_WL\_17)

This detention basin has a little sediment accumulation at the inlet closest to the entrance drive, and some sediment accumulation in the basin. Wetland vegetation has established itself in this basin due to consistent moisture conditions. Low-elevation orifice is a caged rectangular opening, which could be easily partially blocked to add some retention volume and increase treatment. Reducing the size of this orifice would add some improved peak shaving of the storm hydrograph, which would benefit the Brush Run stream channel immediately downstream of the outfall. Alternatively, or in addition, some excavation or sediment removal could add some depth to the basin floor. No access issues or apparent utility conflicts exist.

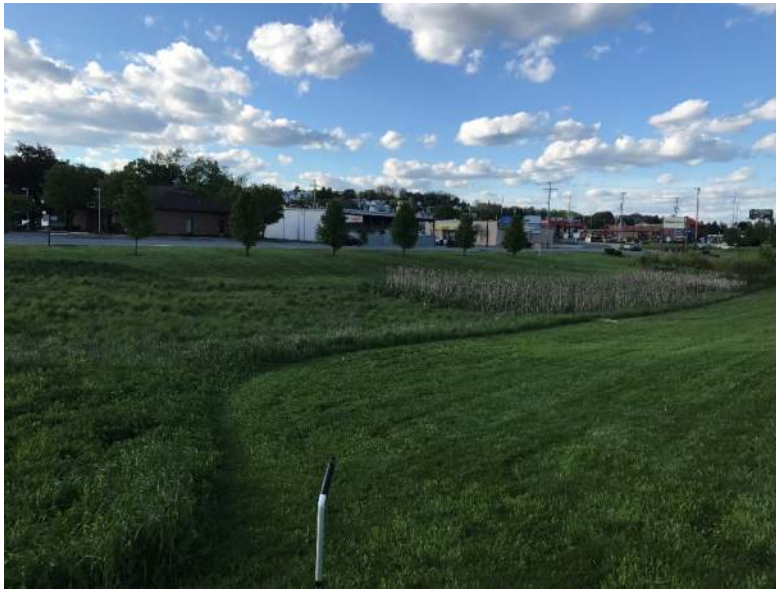
## Healtsouth 2 (PRP\_P\_WL\_18)

Recommendations include excavating some deeper pool areas to increase detention volume, and potentially increasing the footprint in the available space between the basin and Valley View Blvd. An alternative would be to add a weir structure at or near the entrance drive culvert, thereby increasing the effective outlet elevation to increase detention volume.

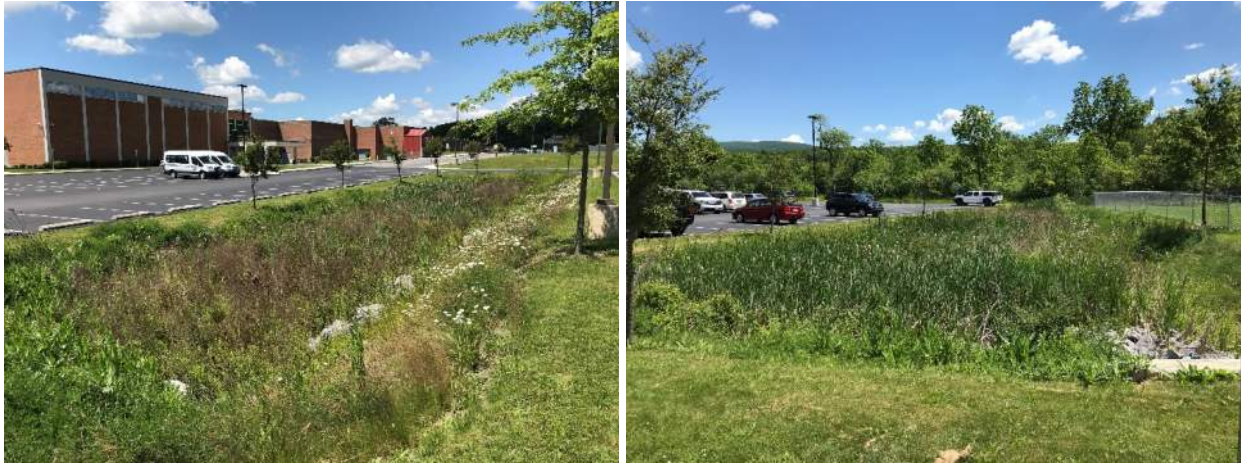
## Hollidaysburg Area Senior HS (PRP\_E\_WL\_19)

Existing detention basins at Hollidaysburg Area Senior High School have naturally evolved into pocket wetlands which are providing some water quality treatment and some ecosystem services. These basins are adjacent to parking lots. They receive runoff from sports fields, buildings, and parking lots. They appear to be in good condition, and no action is recommended.

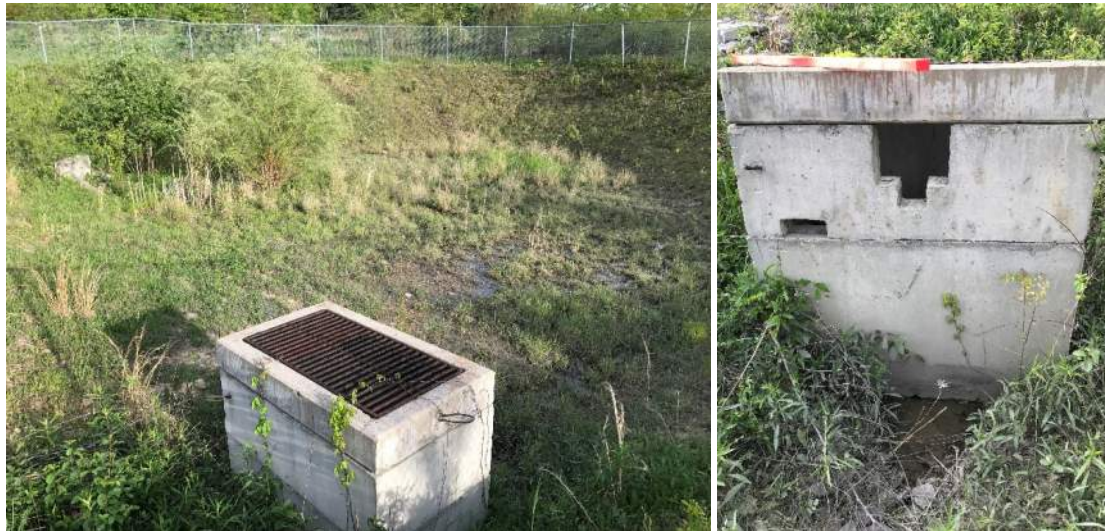
## Logan Town Centre / Hilton Pond 1 (PRP\_P\_WL\_21)

This small detention basin actually has a seemingly well-designed outlet structure for extended detention. It currently receives runoff from a largely pervious drainage area, but it appears that development is planned immediately adjacent to it, and given the location, it is likely that it is commercial in nature. Recommendation is to excavate the bottom to add depth below the low-flow orifice. Alternatively, if the detention function will not be adversely affected by this, raising the low-flow orifice by either blocking it and adding a new one above it, or adding an upturned standpipe, will add retention volume. Access is easy, and there are no apparent utility conflicts.

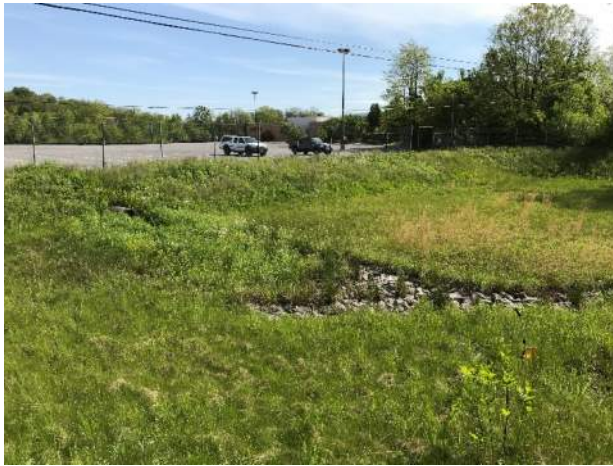
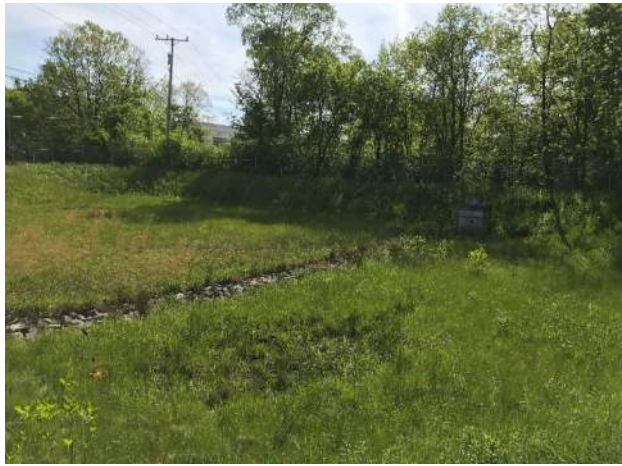
## Logan Valley Mall (PRP\_P\_WP\_22)

This detention basin serves as rate and peak velocity control for a portion of the Logan Valley Mall property, largely impervious in nature due to the parking lot and buildings. The low-elevation orifice is six (6) inches in diameter, and therefore this is unlikely to detain any water for a sufficient period to provide much service in peak shaving of the storm hydrograph. There is a riprap-lined path from the inlet to the outlet which may have been installed to stabilize a gulley. The basin floor was a little soggy at the time of the site visit, but only very near this flow path. Recommendations include either removing the riprap, or merely adding a short transverse berm about halfway through the basin to increase the flow path length. Also recommended is blocking the bottom four to five (4-5) inches of the low-elevation orifice, or adding a perforated standpipe to lengthen the detention time. A good combination effort would be blocking the low-elevation orifice, adding a new two inch (2") orifice with an invert 12 inches above the existing orifice, and adding a short transverse berm to increase the flow path through the detained water. This would add water quality treatment, and downstream channel protection functions. No access issues exist, and no utility conflicts are apparent.

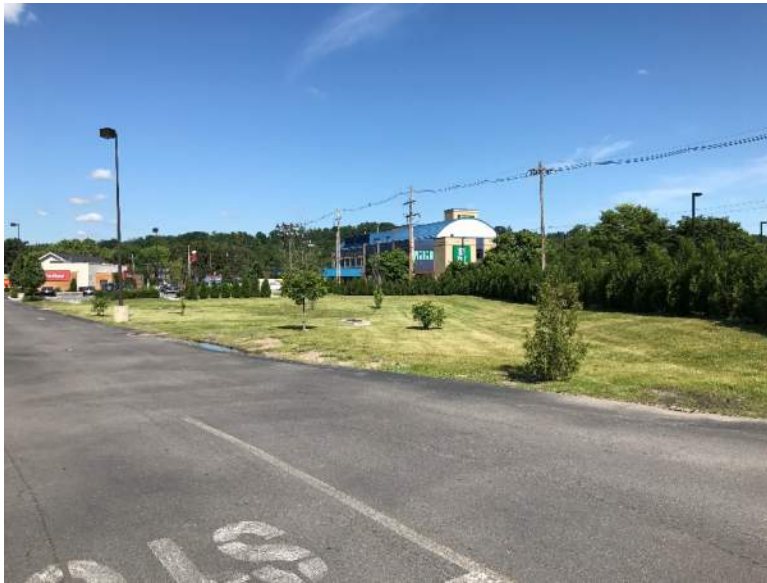
## Martin's Grocery (PRP\_P\_BR\_23)

A very feasible retrofit to provide water quality benefit without much modification to the existing infrastructure would be to remove the top 1-2 feet of soil, being careful of the connecting storm drain pipes, add underdrain pipes connected to the concrete inlet structures, a layer of underdrain gravel, and replace the top layer with sand to create a surface sand filter. The existing yard inlet grates would still function as overflows for the sand filter, but the runoff would be able to permeate and be filtered by the sand before draining into the lower portions of the inlets.

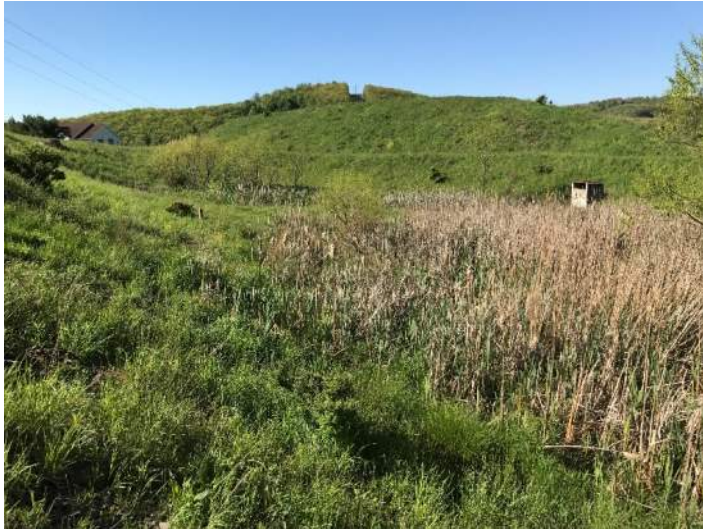
## Nittany Pointe 1 (TMDL\_P\_WP\_7)

This dry detention basin has remained wet enough to grow some wooded wetland vegetation. The inflow from the pipe short-circuits to the outlet. The outlet and the overflow appear to be in good condition, however the low-elevation orifice is 12 inches in diameter, which precludes any useful volume control except in the most severe peak flows.

Given that there is room to expand the footprint of this BMP, and it is located in the TMDL area, an excavation and footprint expansion is recommended, along with an outlet structure modification to reduce the size of the low-elevation orifice. Some hydraulic calculations are necessary to confirm this, but a 3-inch orifice will likely suffice and provide better velocity control. It is recommended to block the existing low orifice and add the new low-flow orifice above it to provide greater detention time, allow some infiltration, and achieve better water quality treatment.

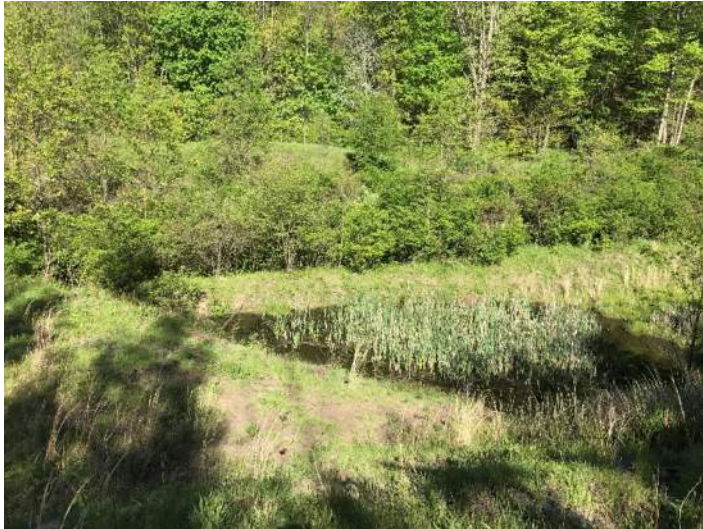
## Nittany Pointe 2 (TMDL\_E\_WP\_8)

The Nittany Pointe 2 basin receives runoff from the land above the Nittany Pointe housing, almost exclusively pervious drainage area. The basin itself has no obvious outlet, but the water surface elevation was not at the lowest natural overflow point, so the water within it is either infiltrating to a degree, or moving laterally to the adjacent stream which is immediately west of the basin. The basin has established emergent and submerged wetland vegetation, algae, and amphibious inhabitants.

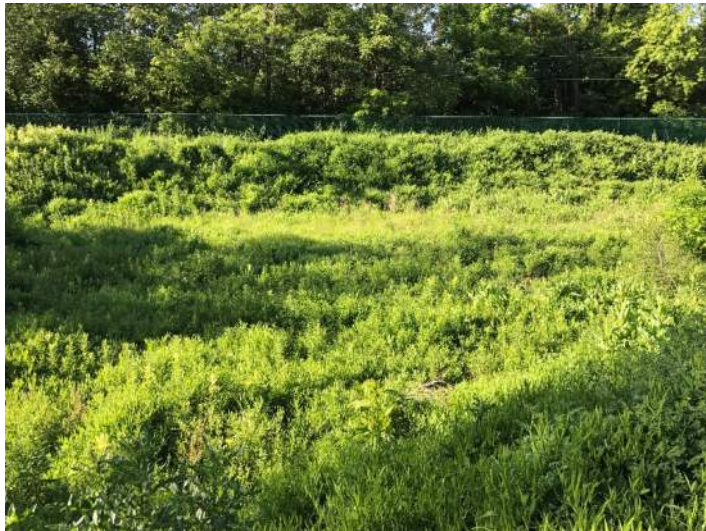
## Pleasant Valley ES (PRP\_P\_BR\_24)

The dry detention basin at Pleasant Valley Elementary School is in good condition, but vegetation management has either been lacking or has been purposefully allowed to thicken around the outlet structure. As such, any modifications to the outlet structure will likely require more than mowing since two-inch diameter black locust trees and other woody vegetation have become well established immediately in front of the outlet. Recommendation for retrofit is simple: block lowest elevation orifice, and block bottom half of the second orifice. The remaining orifices, coupled with likely permeable soils, should be able to manage influent without issue. There is ample head from inlets to basin floor.

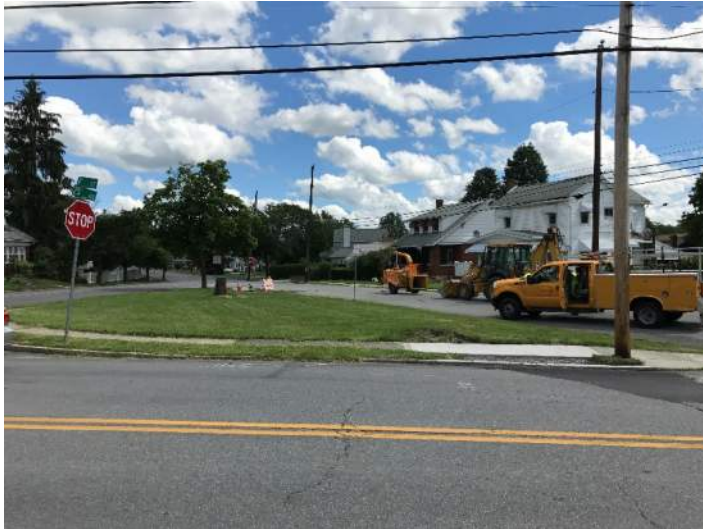
## St. Therese Church Bioretention (TMDL\_P\_BR\_10)

The City of Altoona is installing a bioretention in the traffic island. Engineering designs may be available with the City to confirm assumptions made here. No retrofit or modification is necessary since this is a new BMP being constructed. Drainage area estimates may be off, but site-level survey is required for precision in highly urban locations due to micro-topographical features such as curbs, gutters, slight depressions, and even minor sediment accumulation ridges.

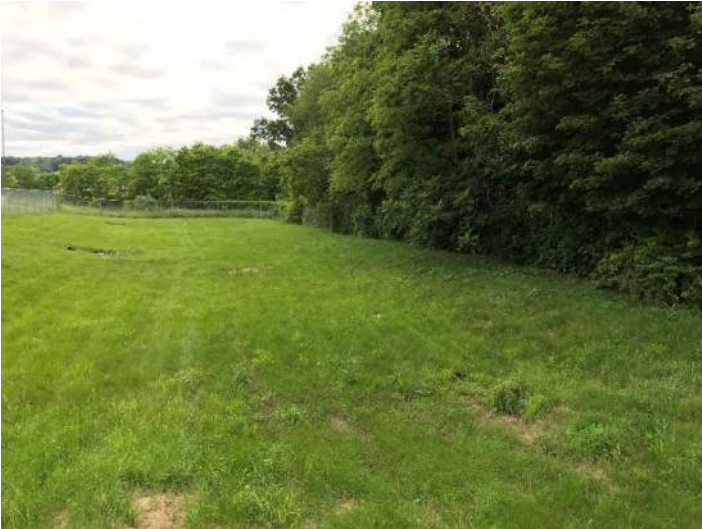
## Strip Mall (PRP\_P\_BR\_25)

This basin is an unconventional design since it has no dedicated outlet structure or channel; it is merely a set of inlets and a shallow depression. Conversation with employees of the retail establishments immediately adjacent to the basin revealed that during larger storm events, water collects in the basin, and then drains down over a period of 1-3 days. This indicates that the basin is functioning as an infiltration basin. As such, the recommended retrofit is merely to increase capacity by removing approximately six (6) inches of soil. Alternatively, if the desire exists to create more of an infiltration and extended detention basin, more soil can be excavated and an outlet structure or channel could be incorporated. This basin is approximately 200 feet from Beaverdam Branch, about 200 feet upstream of Legion Memorial Park. No access or utility issues are apparent.
